**Flood Control Project Maintenance  
Levee Inspections**

## Maintenance Issue Types Only, Levee Inspection Report By Mile - Spring 2017

### Levee District No. 0009 (Sutter County)

Waterway	Bank	Unit Miles	Inspection Start/End	Inspector
Unit No. 01 Sutter County, Feather River	Right	6.25	04/19/2017 04/19/2017	Sterling York

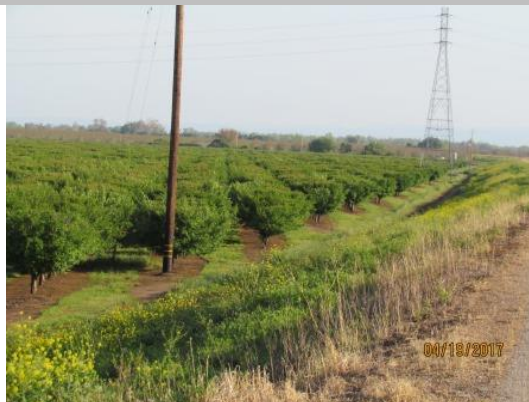
Photo 1 of 1 : SP\_2017\_LD0009\_202\_1\_20170426\_00006.jpg

LM Start	0.02	Rating **	M	Issue No.	1
LM End	6.25	Issue Type +	Ma	Location *	LS
Category	Earthen Levee			GPS Latitude/Longitude	
				Start	End
Item	Vegetation			39.169117 °	39.255839 °
				-121.622620 °	-121.636402 °
DWR ID	DWR_LD0009_01_s_2017_1				
Comment Code					
V1 : Control annual grass and weeds on the levee slopes and easements.					
Inspector Comment					
Annual grasses need to be maintained, Spring 2017.

View looking upstream of annual grasses that need to be maintained, Spring 2017.

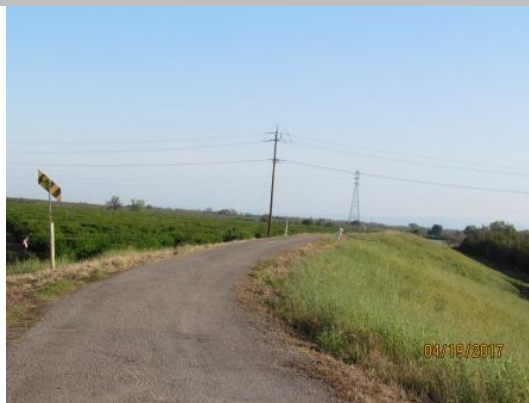
Photo 1 of 1 : SP\_2017\_LD0009\_202\_2\_20170426\_00007.jpg

LM Start	0.02	Rating **	M	Issue No.	2
LM End	6.25	Issue Type +	Ma	Location *	WS
Category	Earthen Levee			GPS Latitude/Longitude	
				Start	End
Item	Vegetation			39.169117 °	39.255839 °
				-121.622620 °	-121.636402 °
DWR ID	DWR_LD0009_01_s_2017_2				
Comment Code					
V1 : Control annual grass and weeds on the levee slopes and easements.					
Inspector Comment					
Annual grasses need to be maintained, Spring 2017.

View looking downstream of annual grasses that need to be maintained, Spring 2017.

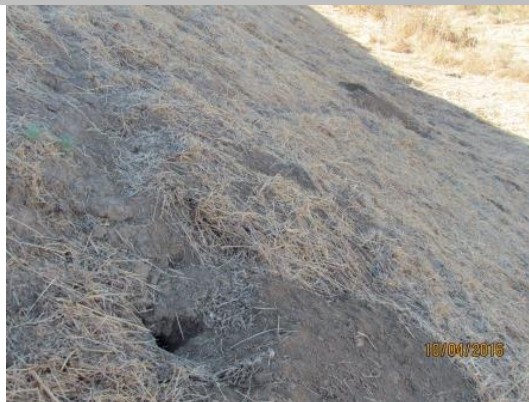
Photo 1 of 1 : SP\_2017\_LD0009\_202\_18\_20170316\_00003.jpg

LM Start	0.09	Rating **	A/W	Issue No.	18
LM End	0.09	Issue Type +	Ma	Location *	LS
Category	Earthen Levee			GPS Latitude/Longitude	
				Start	End
Item	Animal Control			39.170064 °	39.170064 °
				-121.622563 °	-121.622563 °
DWR ID	DWR_LD0009_01_f_2016_18				
Comment Code					
A3 : No rodents visible, but rodent burrows visible; need to backfill and compact or grout burrows.					
Inspector Comment					
No animal activity. Rodent holes need to be backfilled. Spring 2017.

View of rodent holes that need to be backfilled, no sign of rodents at time of inspection. Fall 2016.
